## SWIVEL BRACKET BUSHING GREASE PATH

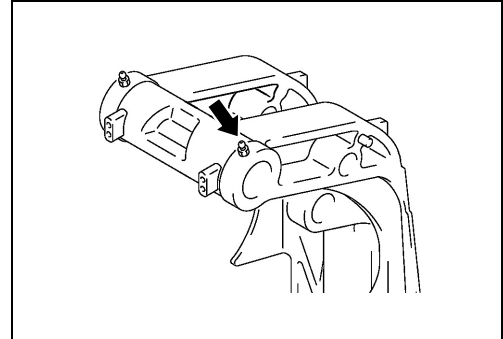
The swivel brackets have been redesigned from two to only one grease nipple on the port side.

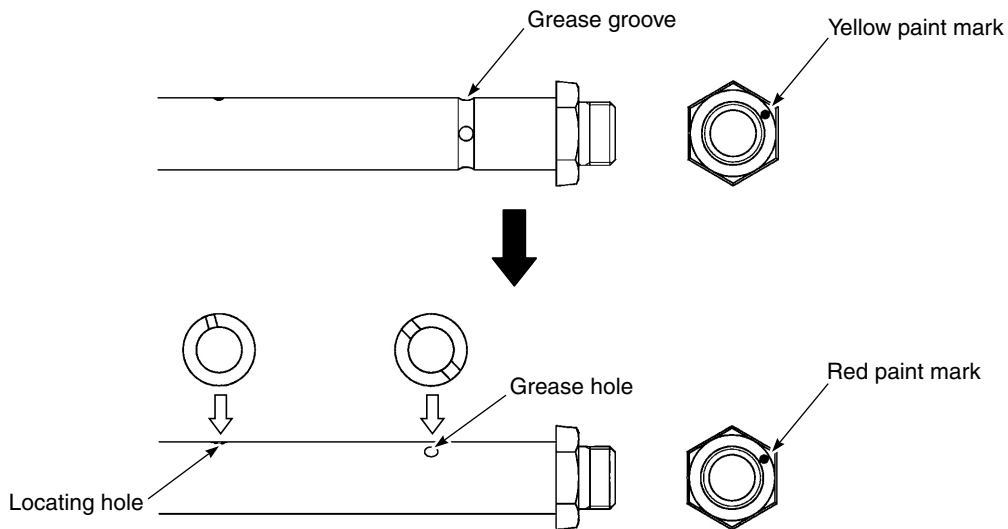
The clamp bracket shaft has been redesigned with a clearance hole in place of a slot for routing the grease lubrication.

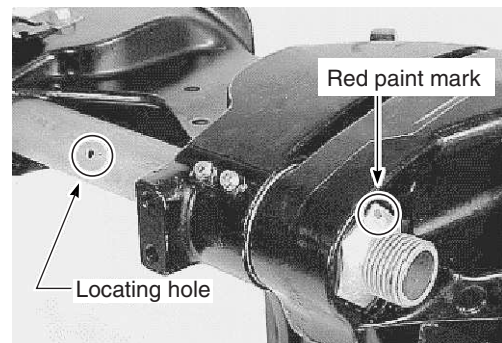
Install the clamp bracket shaft with "Red" paint marking toward up side.
