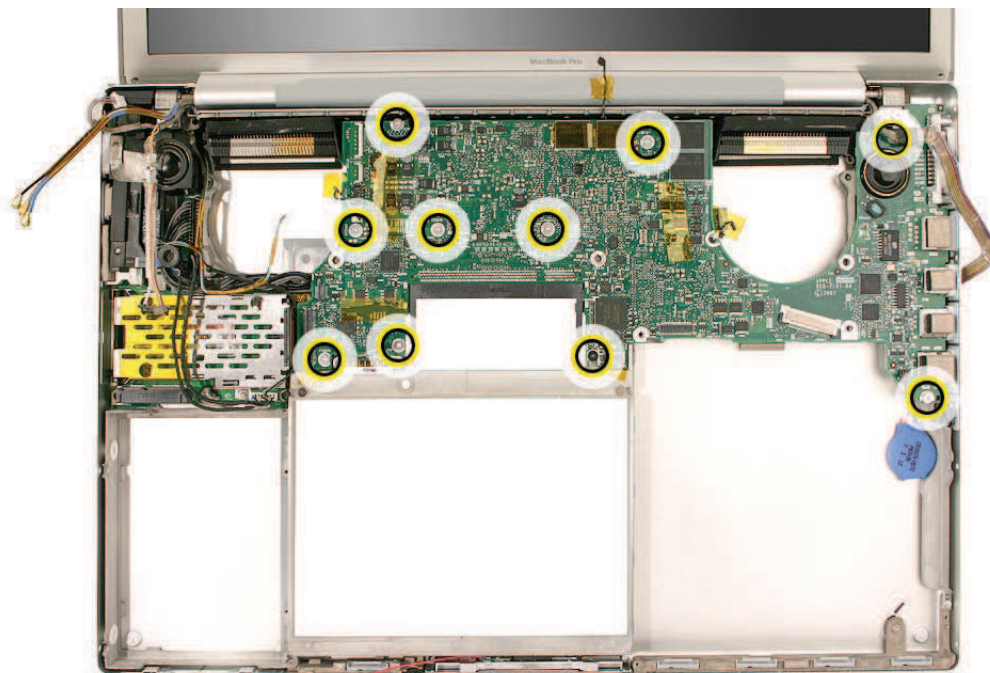
3. Remove nine silver Torx T6 screws and one black Phillips screw just above the right side of the battery bay.

Note: The screw on the upper right corner of the logic board is actually *underneath* the LVDS cable (for which a longer Torx T6 screw was removed in step 1 of this procedure).
